Manhole Inspection Summary

Manhole # S37U1_012MH

Insp Date: **2/19/08 1:27 PM**

Location Address: **3435 S Hanover St**

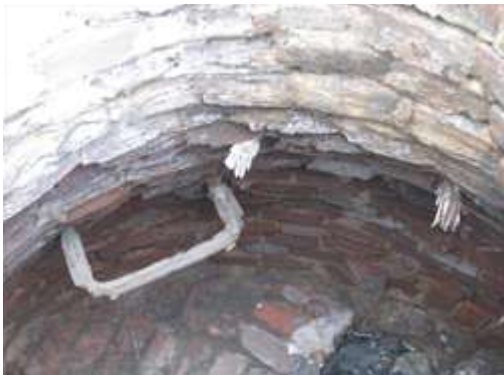
Steps

Count: **2** Missing: **1** ☒ **Corroded**

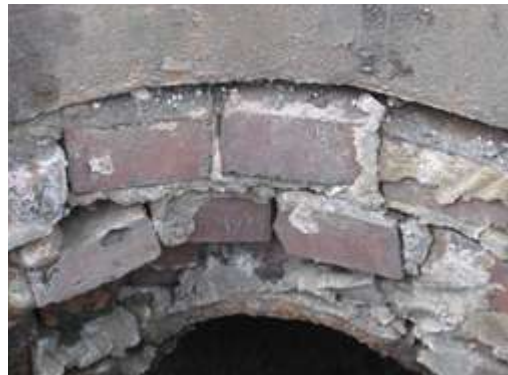
Defect 1

Condition: ☐ Sound ☐ Cracked ☐ Root Intrusion ☒ **Loose Brick** ☐ Deteriorated

Infiltration: ☐ None ☒ **Joint** ☒ **Cracks** ☒ **Mortar** ☐ Roots ☒ **Wall**

Chimney

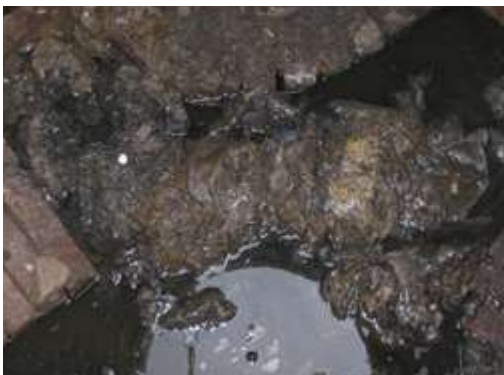
Defect 2

Condition: ☐ Sound ☐ Cracked ☐ Root Intrusion ☐ Deteriorated ☐ Leaks ☒ **Debris**

Channel

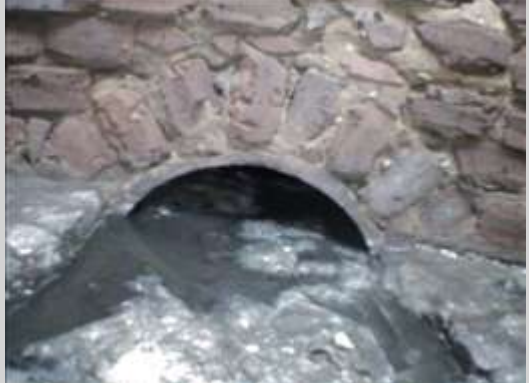
12 O'Clock Outflow

12 in. Circular Gravity Sewer
Pipe Out @ 12 O'Clock

Pipe Height: **14.4** (in.) Rod and Bar (Angled)
Pipe Material: **Clay** ☐ Pipe Lined
Invert Depth: **6.25** (ft.) Flow Characteristics: **None**
Deposits: ☒ None ☐ Mud ☐ Sludge ☐ Debris ☐ Grease
Silt Depth: (in.) Deposits Extent:
Infiltration: **None** Pipe Seal Cond: **Sound**

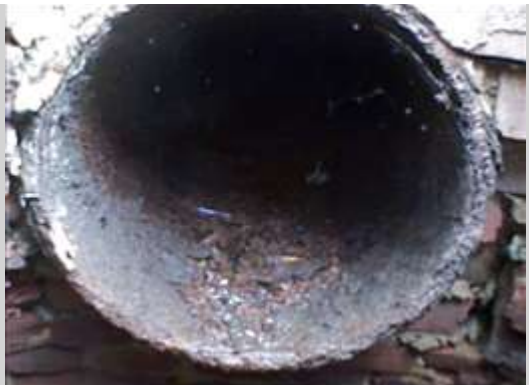
1 O'Clock Inflow

12 in. Circular Gravity Sewer
Pipe In @ 1 O'Clock

Pipe Height: **12** (in.) Rod and Bar (Angled)
Pipe Material: **Clay** ☐ Pipe Lined
Invert Depth: **2.52** (ft.) Flow Characteristics: **None**
Deposits: ☒ None ☐ Mud ☐ Sludge ☐ Debris ☐ Grease
Silt Depth: (in.) Deposits Extent:
Infiltration: **None** Pipe Seal Cond: **Sound**

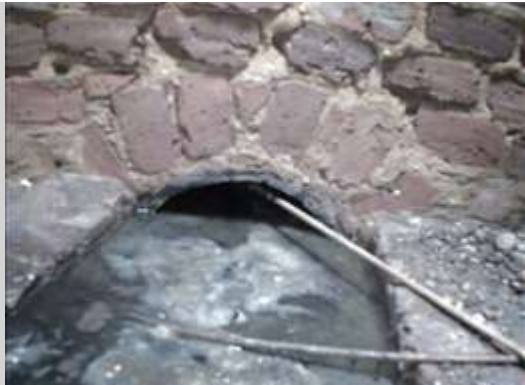
3 O'Clock Inflow

8 in. Circular Gravity Sewer

Pipe In @ 3 O'Clock

Pipe Height: **8.4** (in.) Rod and Bar (Angled)

Infiltration: **None** Pipe Seal Cond: **Sound**

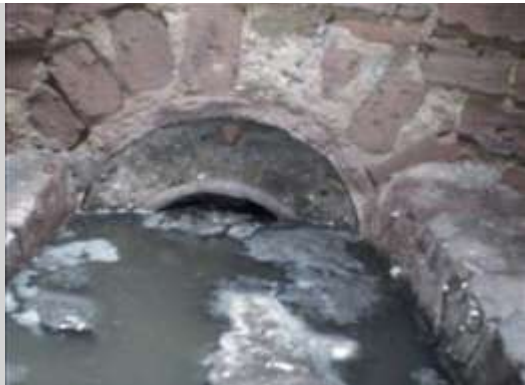
6 O'Clock Inflow

8 in. Circular Gravity Sewer

Pipe In @ 6 O'Clock

Pipe Height: **7.2** (in.) Rod and Bar (Angled)

Infiltration: **None** Pipe Seal Cond: **Sound**

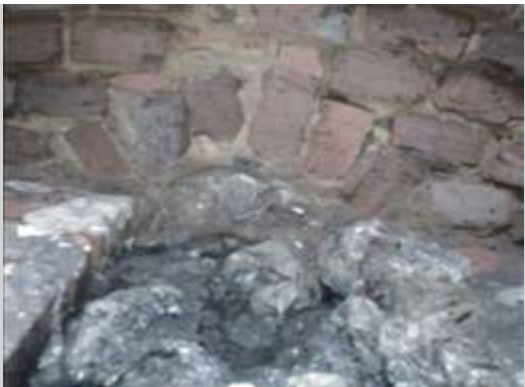
9 O'Clock Inflow

8 in. Circular Gravity Sewer
Pipe In @ 9 O'Clock

Pipe Height: **7.2** (in.) Rod and Bar (Angled)
Pipe Material: **Clay** ☐ Pipe Lined
Invert Depth: **5.88** (ft.) Flow Characteristics: **None**
Deposits: ☐ None ☐ Mud ☒ **Sludge** ☒ **Debris** ☐ Grease
Silt Depth: **5.6** (in.) Deposits Extent: **Heavy**
Infiltration: **None** Pipe Seal Cond: **Unknown**
